**SUBJECT:** Operational Report - Lessons Learned, Headquarters, 35th  
Engineer Battalion (Combat), Period Ending 31 July 1968

**DEPARTMENT OF THE ARMY  
HEADQUARTERS 35TH ENGINEER BATTALION (COMBAT)  
APO San Francisco 96337**

**SUBJECT: Operational Report - Lessons Learned, Headquarters,  
35th Engineer Battalion (Combat), for the Quarter  
Ending 31 July 1968, RCS CSFOR-65 (R1)**

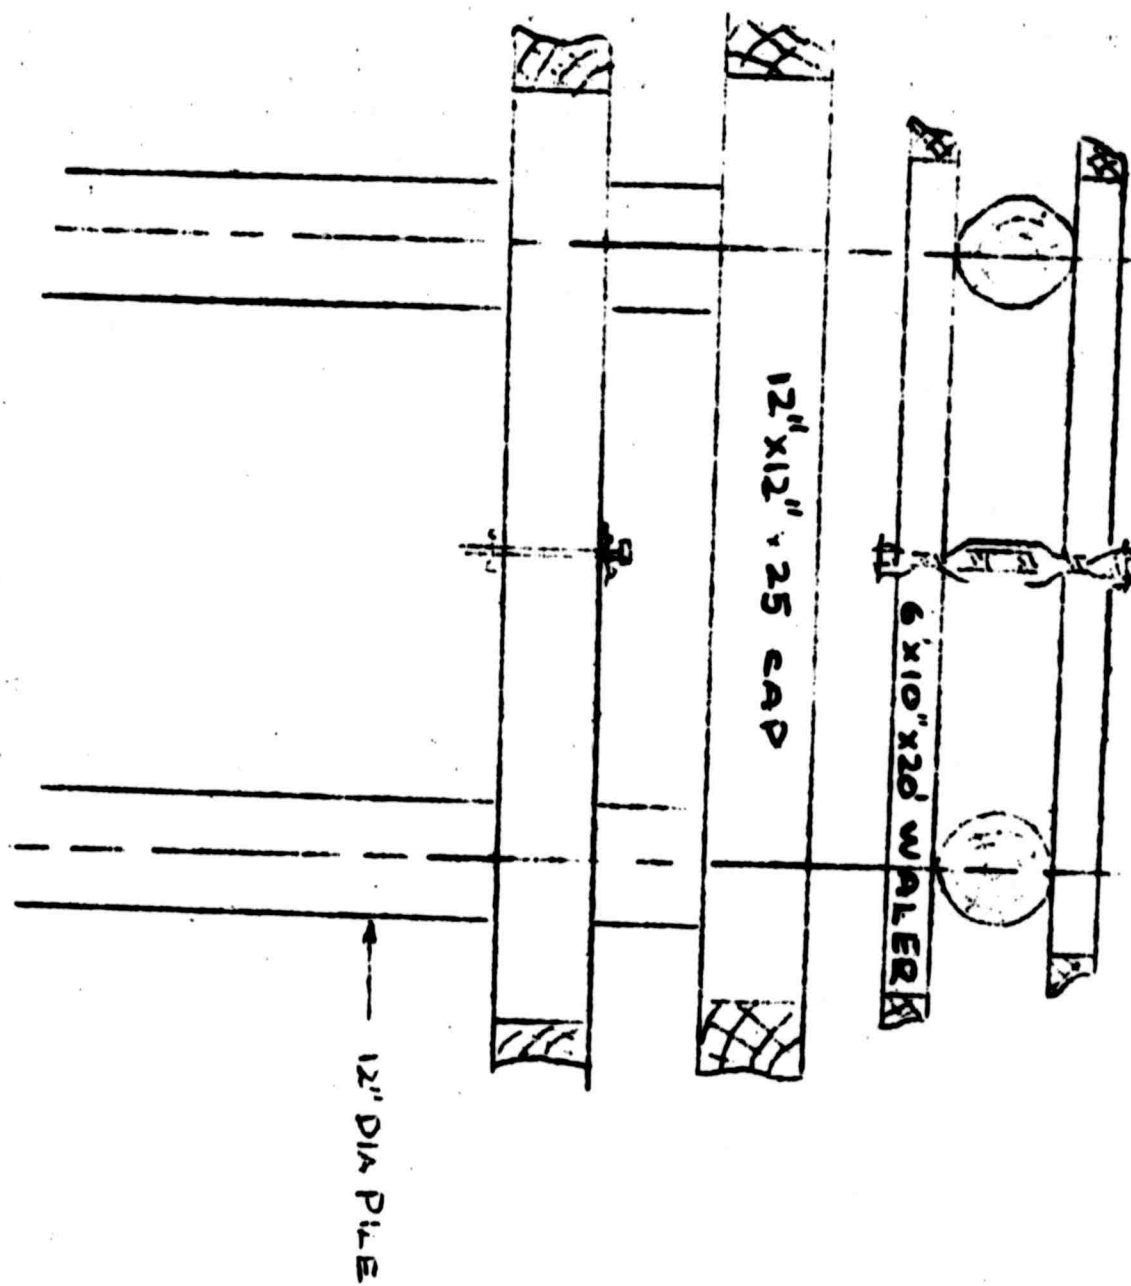
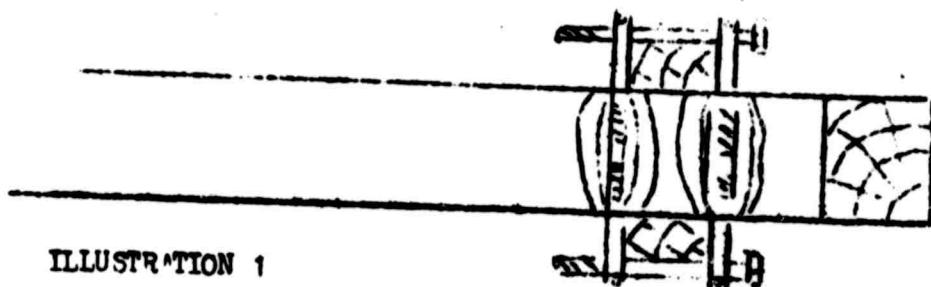
ILLUSTRATION 1

(a) OBSERVATION: Where piles had to be aligned and no materials existed besides materials for the bridge itself, an expedient was necessary to hold the piles in line as they were capped. The materials for the aligning frame had to be constructed of bridge materials, yet the materials had to be completely reusable on the bridge or a succeeding bridge.

(b) EVALUATION: The items used for the aligning frame of the pile bent consisted of two timber walers (6" x 10" x 20'), deadmen turnbuckles, and 20-inch bolts used to secure the curbs. The timber walers were placed parallel to and one on each side of a pile bent. The walers were drawn together by a double turnbuckle system described in illustration 1. One turnbuckle set was placed between each two piles, a 20-inch bolt was used to turn the turnbuckles. After the piles were brought into alignment and capped, the materials were free to be used for their originally intended purpose.

(c) RECOMMENDATION: This method be considered if an expedient means of aligning piles is needed. (Illustration 1 and 2)

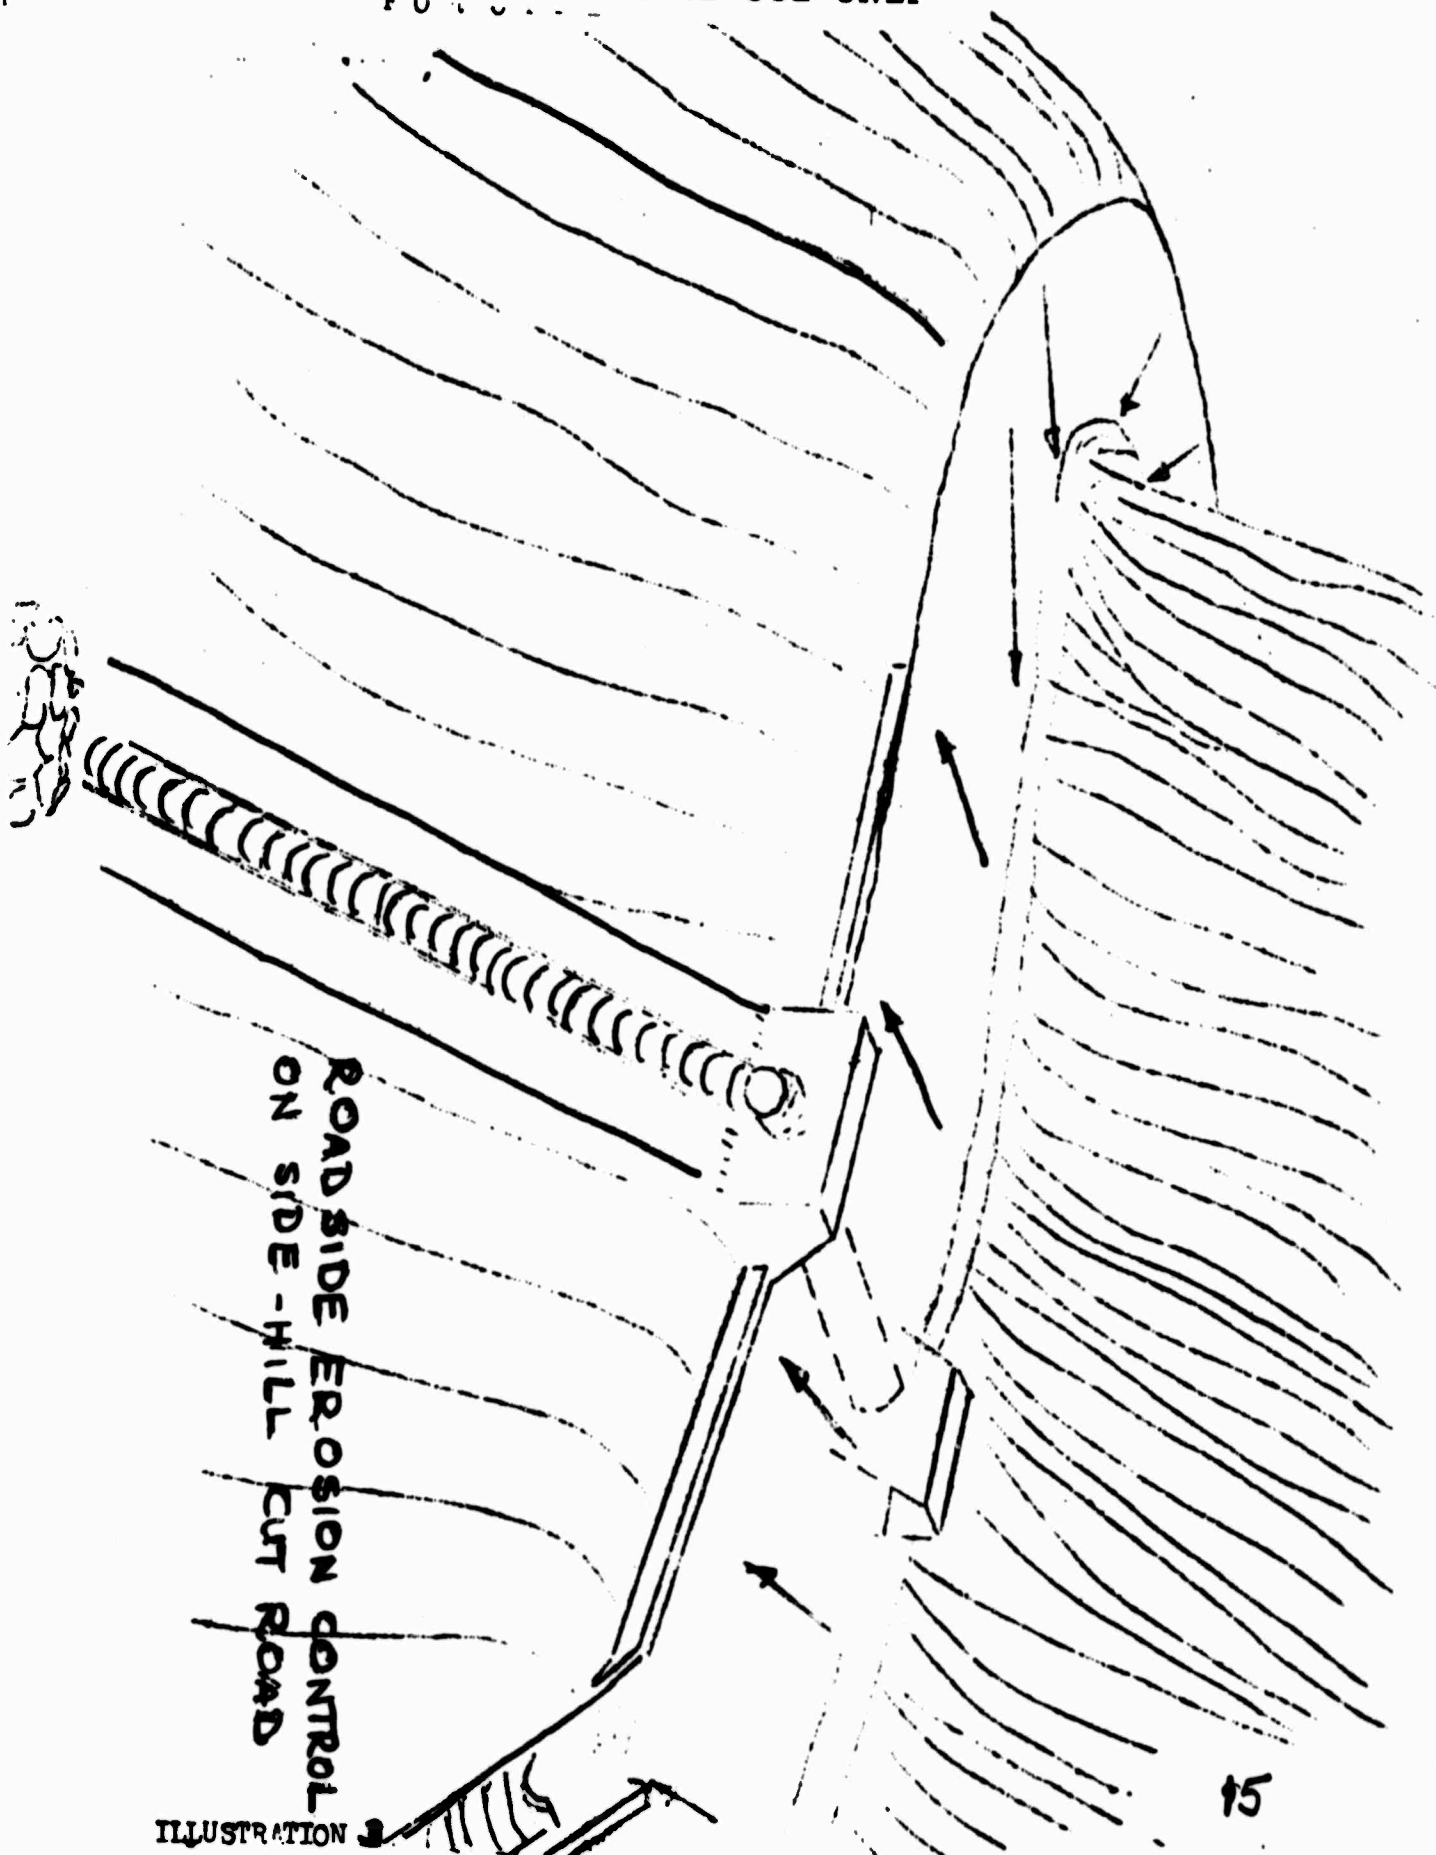
ILLUSTRATION

(a) OBSERVATION: Superelevated curves which drain across the road down-hill caused significant erosion on the downhill side of the road due solely to road runoff.

(b) EVALUATION: A masonry curb was constructed on the downhill side of the road parallel to the road centerline to a point lower in elevation where the superelevation reverses and carries the runoff to the inside ditch. The water can also be directed to a spillway

constructed on the downhill side of the road. The shoulder between the road and the masonry curbs should be sealed. In this case, 3-inch minus rock was placed, compacted and sprayed with asphalt. This provided a drainage structure resistant to erosion.

(c) RECOMMENDATION: If erosion is a major problem, this method be used. (Illustration 3)

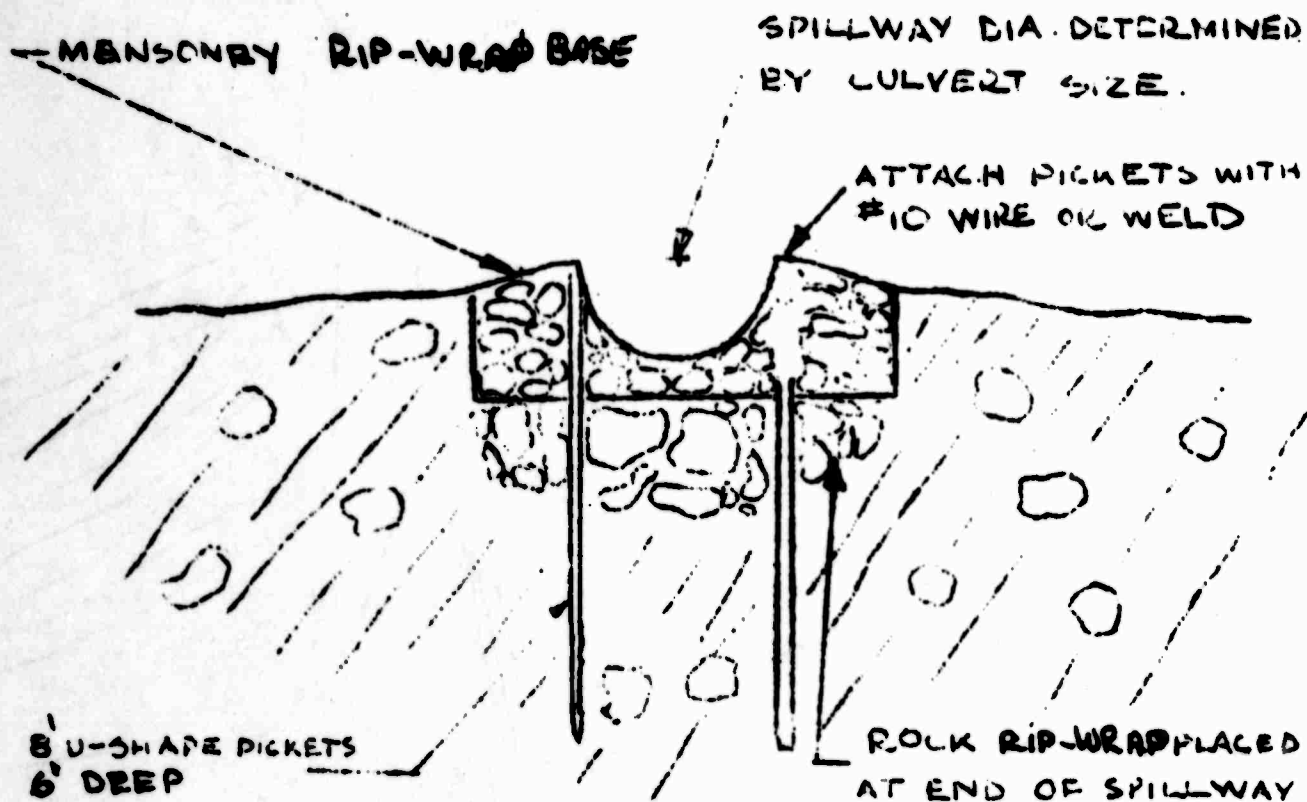
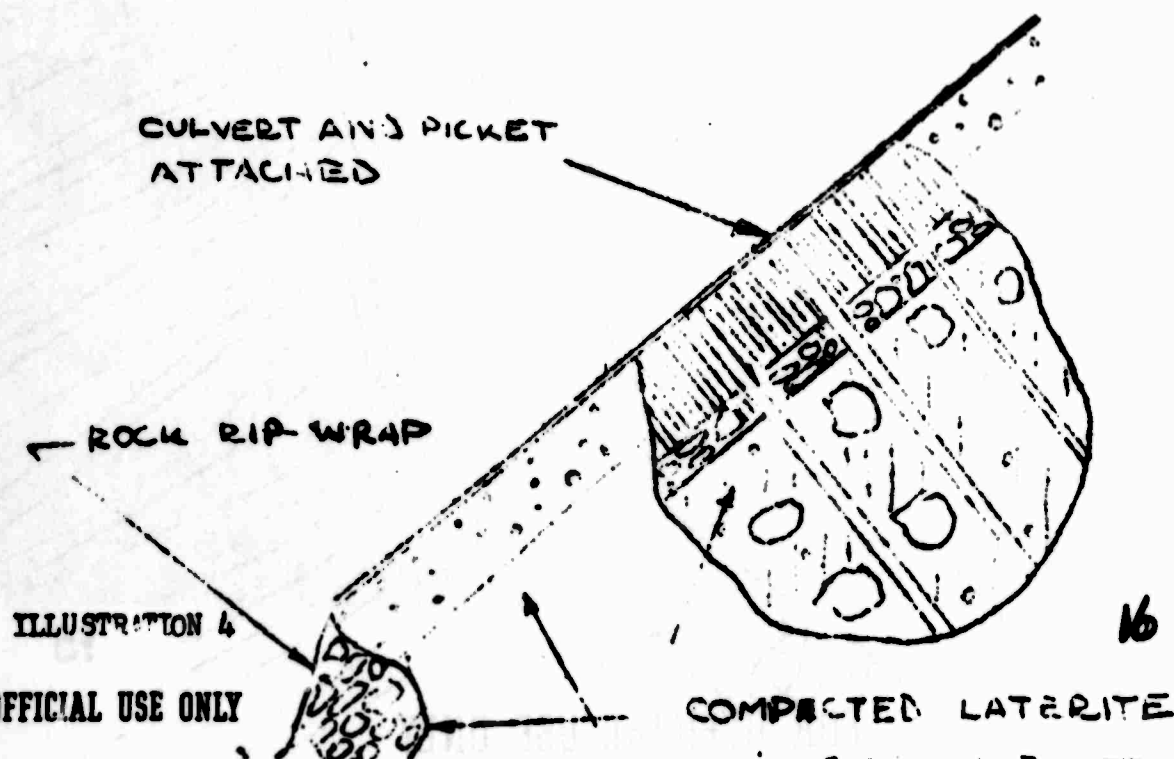
# CULVERT SPILLWAY CONSTRUCTED ON STEEP SLOPES

(a) OBSERVATION: In mountain passes, erosion at the downstream end of culverts presented a problem in spite of placement of rock at the culvert exit. The water would erode the side of the hill under the culvert headwall at such a rate that failure of the headwall might result.

(b) EVALUATION: Construction of half culvert spillways carried the water as far down the hill as necessary to drain on a more gentle slope, rocks or dense vegetation. Eight-foot U-shaped pickets were driven six feet along the length of the culvert. The pickets were fixed to the culvert flange by welding or by heavy gage wire. The picket-culvert complex was supported by placing a masonry base underneath the culvert to surround and tie in with all the pickets. This provided a relatively stable drainage structure.

(c) RECOMMENDATION: Construction of expedient spillways using half section of corrugated metal culvert pipe and steel U-shaped pickets will significantly reduce erosion. (Illustration 4)
